## Case Study - Roadside in Masstown, Nova Scotia

*Large store required restoration of ditch to remove high volumes of water at certain times of the year plus standing water at other times of the year. After just one pass the ditch was restored and land became manageable again.*

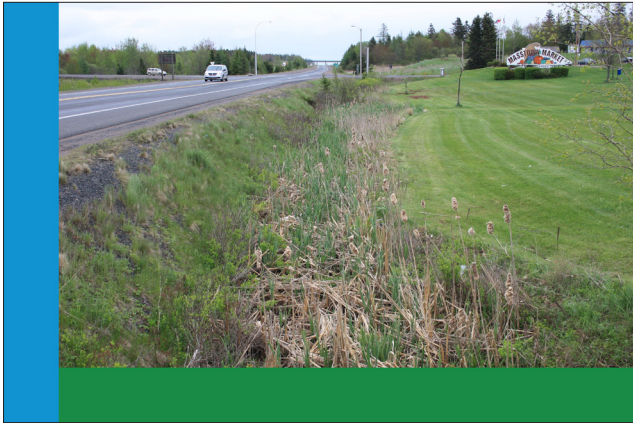
**BEFORE** - The area had become filled with silt and vegetation. Water levels increased and the area became impossible to maintain. The area was saturated with water.

The problem they were experiencing was large volumes of water from the road surface combined with large water run off was not draining away. The ditches were filled with silt and vegetation making them unable to mow and maintain the front of the property. They required the existing ditch that had been become blocked and overgrown with vegetation be restored.

The shape of the ditch would need to handle both large volumes of water in the spring and also remove standing water other times of the year. Minimal impact to the local environment and traffic during the project was also important.

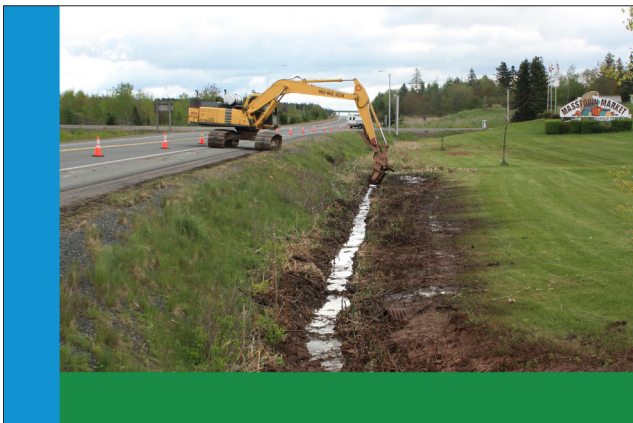
**DURING** - Ditch Doctor® was able to control where the ditch spoil deposited as needed ranging from 3 meters to 20 meters and self levelled.

The solution was to access the ditch from the roadside allowing the spoil to be thrown on to the field opposite. As the ditch had been established in the past it was possible to reshape just the lower level of the ditch back to a more efficient contour. In this case there was no need to amend the existing slope of the ditch and there was no major debris that could not be handled by the Ditch Doctor®.

The intention was one single and continuous pass systematically removing the material causing the blockage and reshaping the ditch at the same time. Traffic was managed by cones and no additional trucks would be required.

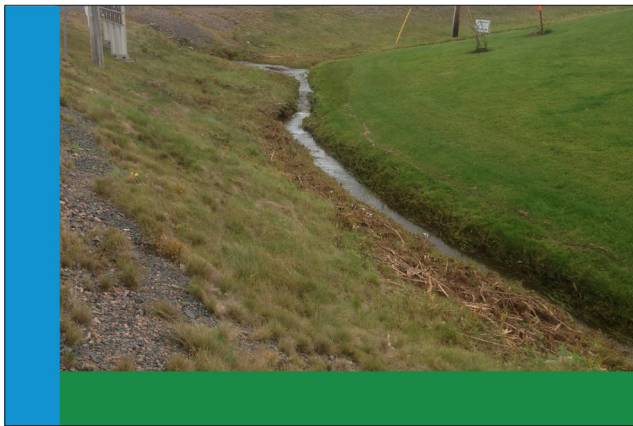
**1 MONTH** - Vegetation grew through it in no time and the area quickly became manageable .

This project was completed on time and on budget. There was no need for additional trucking away of the spoil and reducing traffic congestion provided a safer work zone. This enabled only the hard shoulder to be shut also reducing traffic congestion. The water run off from the main highway is now managed more efficiently and now culverts are working at full capacity.

The land remains free of standing water and they are able to mow right to the edge keeping vegetation controlled and insects minimized. The area is now manageable and more presentable for their business.

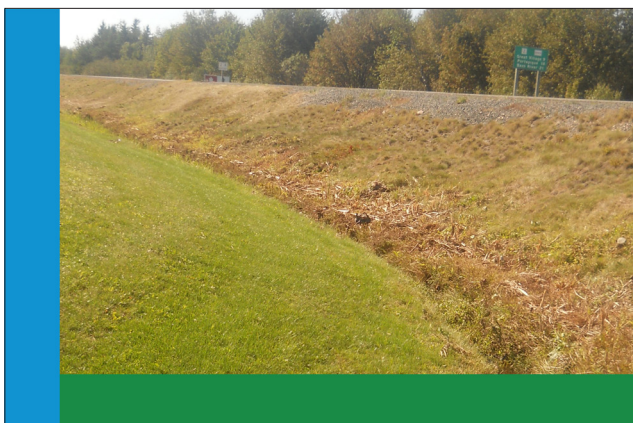
**1 YEAR** - Vegetation quickly grew through material that was deposited from the clean out and the area is now manageable to the ditch line.
